# HISTORIC AMERICAN TIMBER-FRAMED STEEPLES

## *IV. Reproducing Burned or Destroyed Steeples*

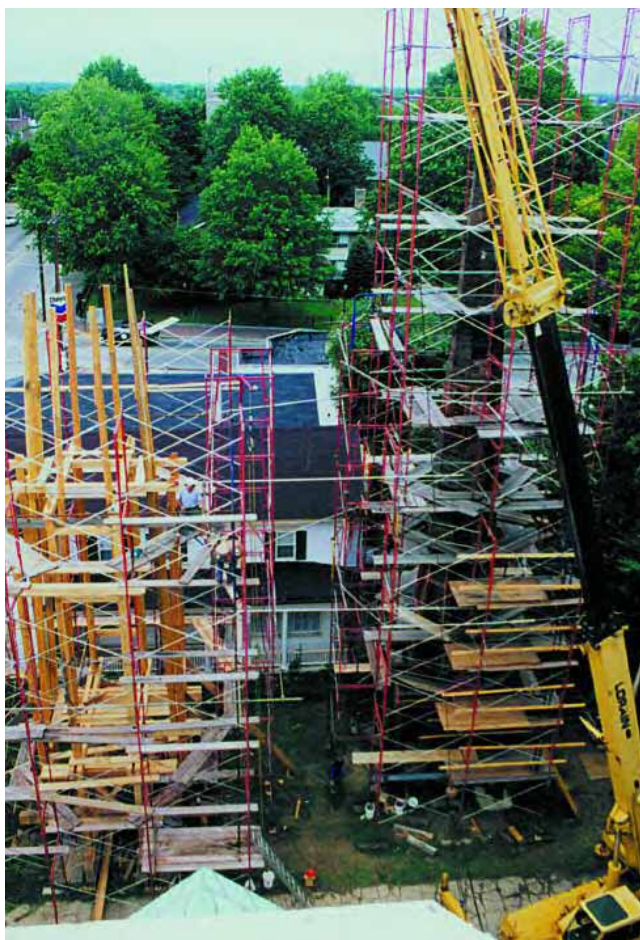
*Fig 1. Perfect original spire frame on right, totally replaced middle stages on left, awaiting lift onto Salem, N. J., Presbyterian Church, 1854, out of sight at right.*

At the Salem, New Jersey, Presbyterian Church (1854), the middle stages rotted, requiring complete reframing, while the healthy spire required only recladding (Figs. 1–3). At Christ Church, Philadelphia, built 1753, the wood sills laid upon the lower brick portion of the tower, as well as the feet of some of the great octagon lantern posts, rotted alarmingly by 1771, and the church's builder and designer Robert Smith was called back to repair it. Given the immense size and good condition of the steeple above, it was left in place (somehow supported on jacks, probably in successive segments) while the rotted timber was removed and replaced by built-up plank. Smith scarfed on new bottoms to the belfry posts as needed, and replaced with plank several of what he

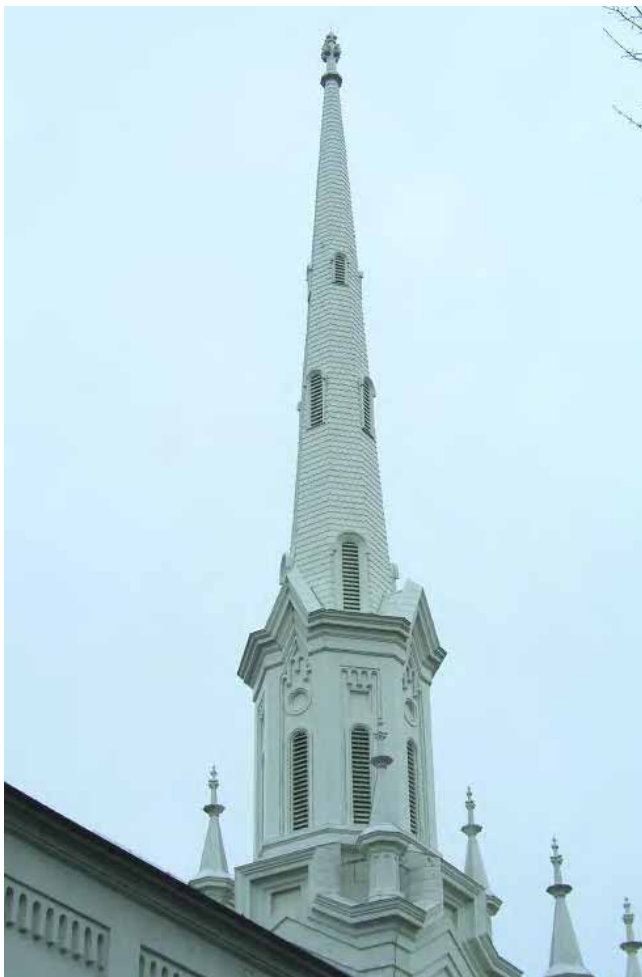
*Fig. 2. Salem Presbyterian Church. Italianate tower is 185 ft. high.*

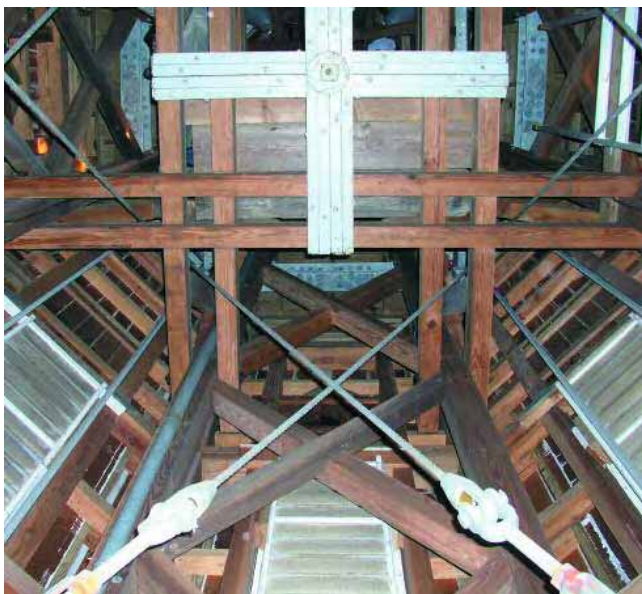
*Fig. 3. Restored middle-stage framing (octagonal stage, Fig. 2) of steeple at Salem. Tall spire above is tied down via long central bolt terminating at laminated crossing that bears up against partners in middle stage.*

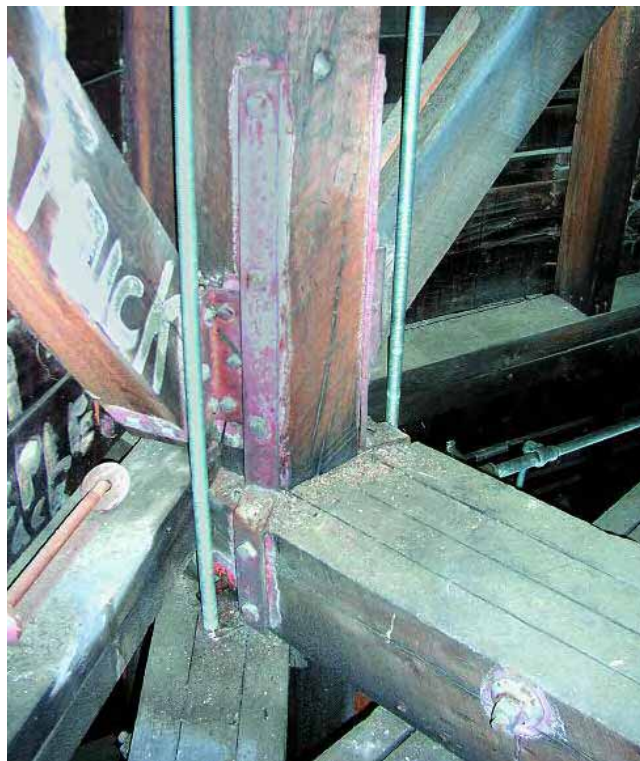
*Fig. 5. Laminated beams replaced rotted material at Christ Church in 1771. Iron straps appear to be original, rods 20th-century.*

called hammer beams, cantilevered members designed to carry the upper posts within the perimeter of a lower square tower. The spire, the ultimate stage of this rescued steeple, escaped water and decay but was destroyed by fire and rebuilt in 1908 (Figs. 4–5).

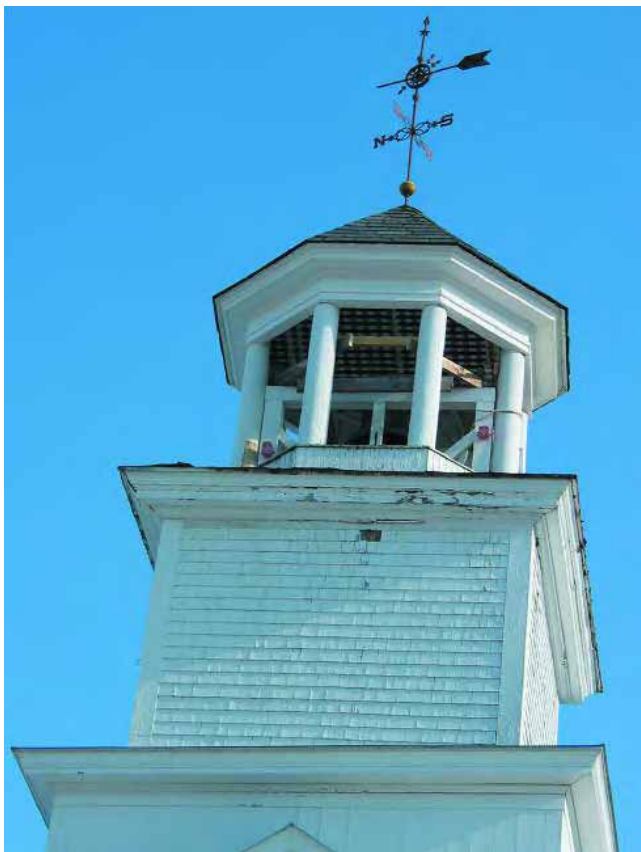
*Fig. 6. Decay in posts and supporting beams led to significant distortion of steeple at the South Woodstock, Vt., Community Church, 1836.*

At the South Woodstock, Vermont, Community Church (1836), the combination of rotted sleepers and tower posts and a rotted and deflected first truss chord caused the modest steeple to tilt out of plumb 7 in. on one axis and 5 in. on the other (Fig. 6). The steeple was restored by dismantling its conveniently telescoped and lodged stages (see TF 85).

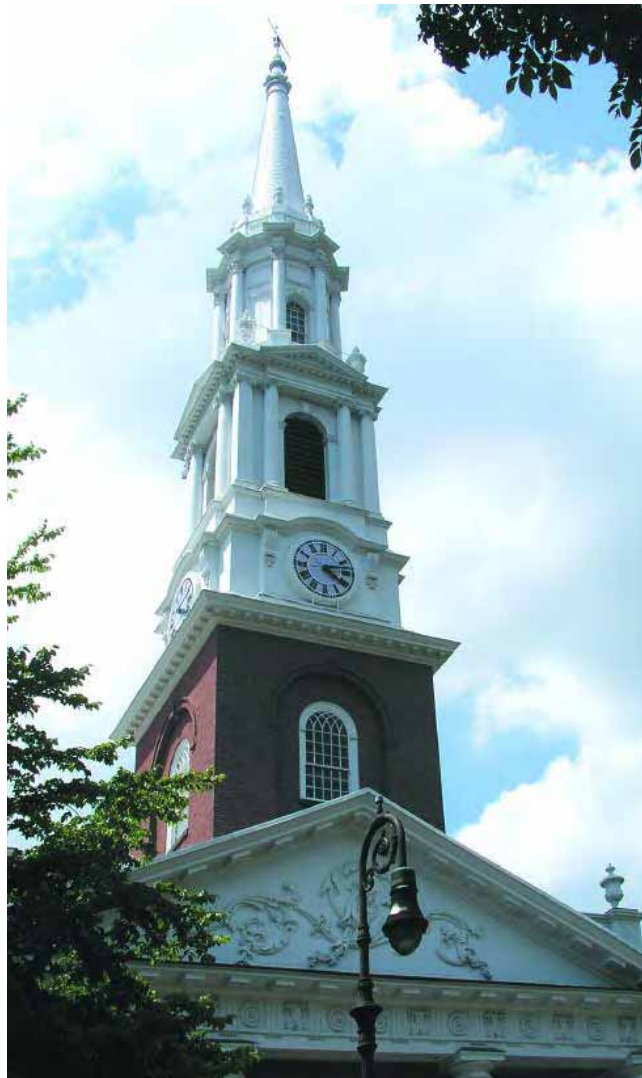
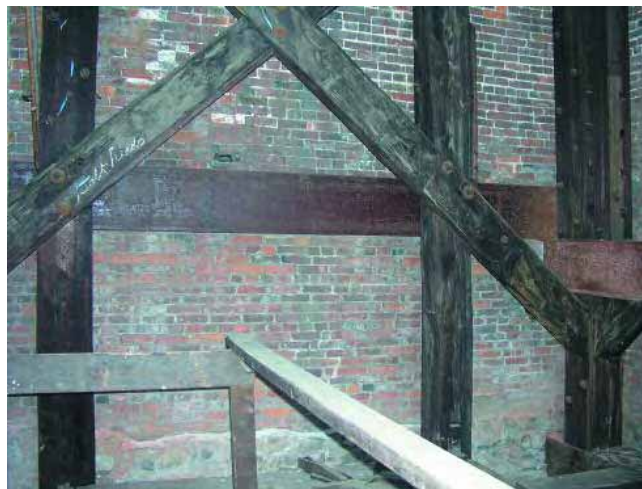
The deep telescoping discussed in previous articles in this series, while offering no lightning protection, is a method of avoiding the tearing off of successive stages by high wind. Telescoping is very different from platform framing. At Ithiel Town's great Center Church (1811) on New Haven Green in Connecticut, for example, the framing of one stage may penetrate as much as 38 ft. into the stage below (Figs. 7–8).

*Figs. 7–8. Center Church, New Haven, Conn., 1811. Deep penetration of stages to those below successfully resists effects of wind. Below, lowest wood-framed stage is deeply lodged in brick tower.*

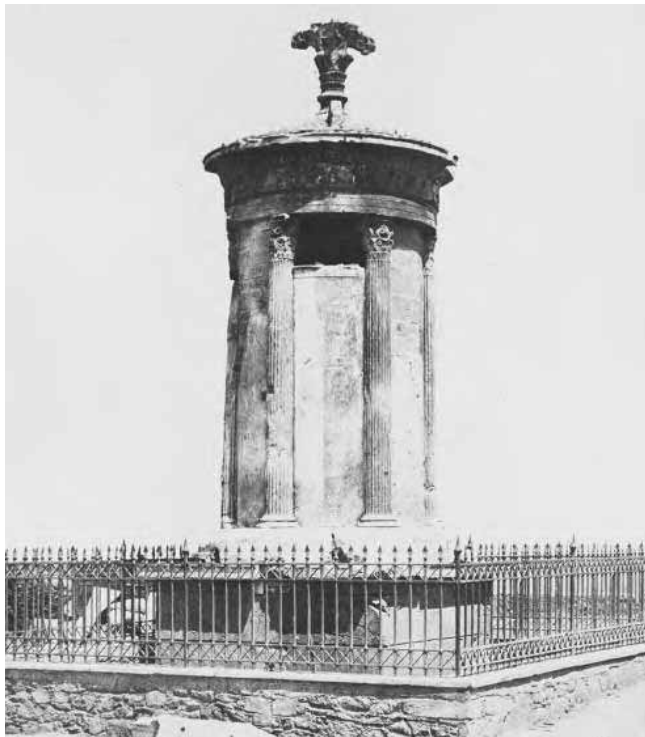
Fig. 9. *The Choragic Monument of Lysicrates, Athens, ca. 350 B.C. Drum surmounting Corinthian columns was adapted to other forms in 19th-century America.*

The open bell deck, a stylistic choice of form that threatens many spires, often provides no concealed space for stages above to drop long posts into stages below. The insertion of an open colonnade of four, six or eight slender posts, sometimes surrounding a bell, is a post-Gothic feature based on certain classical structures such as the Choragic Monument of Lysicrates (Fig. 9). Wren and

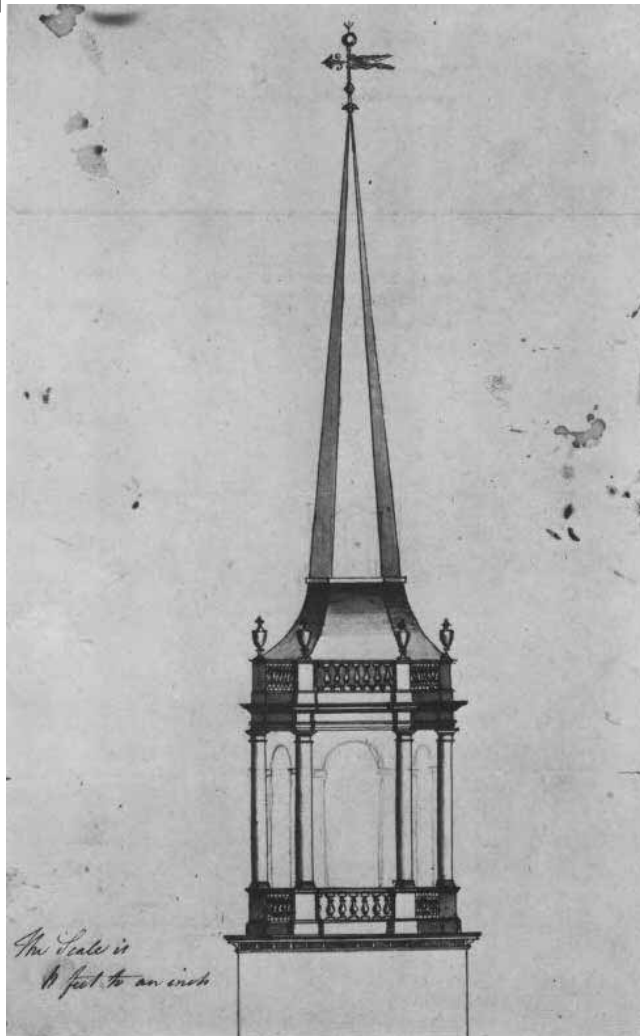
Fig. 10. *Bulfinch's drawing of the steeple at the Congregational Church, Taunton, Mass., 1790–1792. Legend reads: "The Scale is 6 feet to an inch."*

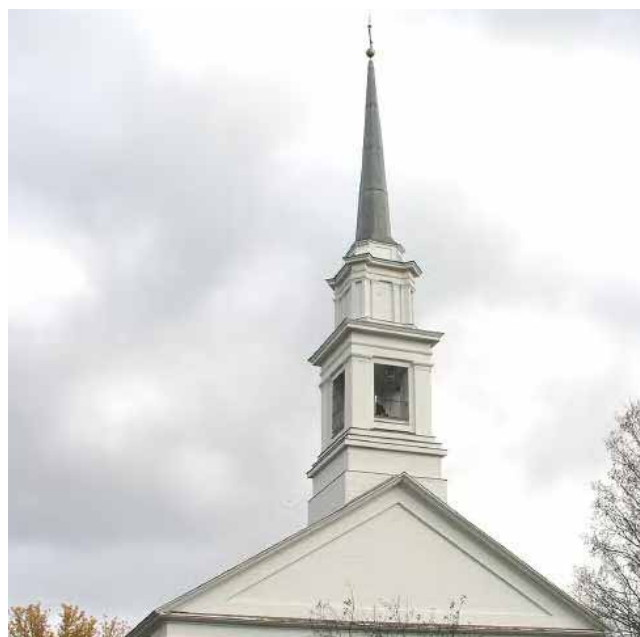
In 1832 at nearby Castleton, Thomas Dake chose the same design to allow telescoping framing of the upper stages to surround the bell invisibly and begin below it. Dake's 9x9x39-ft. white pine posts concealed 28 ft. of their length and emerged for 11 ft. within an irregular octagon above the belfry (Fig. 11).

Fig. 11. *Steeple at Castleton, Vt., Federated Church, 1832, showing thickened belfry corners to conceal telescoped posts from above.*

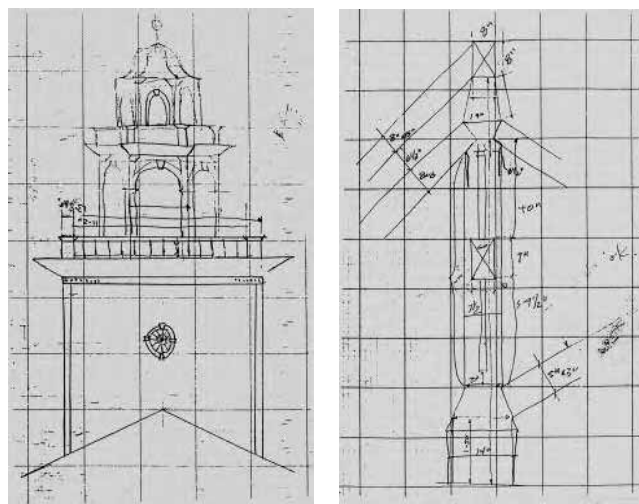
Third, *documentary evidence* may exist in the form of Historic American Buildings Surveys done by the National Park Service and available online ([memory.loc.gov/ammem/collections/habs\\_haer](http://memory.loc.gov/ammem/collections/habs_haer)). These are invaluable documents, but the drawings vary in accuracy and should be compared with other sources of information. Steeple heights, for instance, are established by transit and may not be accurate to within more than a couple of feet. The architects completing the surveys are usually strong on proportions and historic architectural detail, less so on timber frame structure, particularly when so hard of access and so interpenetrated as steeple framing. Nevertheless, at the Weathersfield, Vermont, Meetinghouse, in addition to sketching the exterior of the steeple, a HABS delineator had penetrated the attic space and produced a very useful measured sketch of a kingpost and its entering members (Figs. 12–13).

**Figs. 12–13.** HABS fieldworker’s notebook sketches of Weathersfield, Vt., Meetinghouse steeple and measured detail of kingpost roof truss.

*Framing the trusses.* The HABS field notebook sketch of a kingpost (Fig. 13), reconciled with surviving charred timbers including the timber plate and some bottom chord ends still in place atop the brick walls, gave dimensions and the truss form. There was plenty of evidence among the charred timbers to indicate the joinery, and the original stirrup-straps and forelock bolts that joined kingpost to chord were reusable.

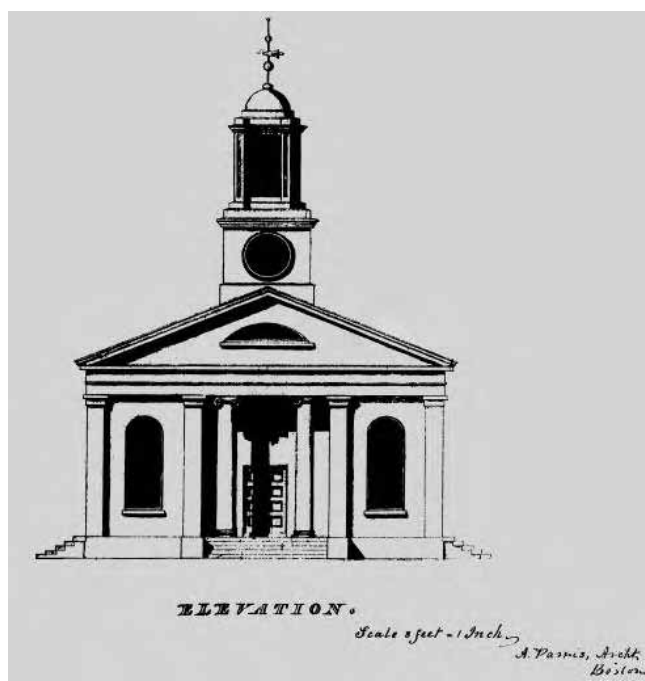
Fig. 14. Alexander Parris's front elevation for St. Paul's Episcopal Church, Windsor, Vt., 1822 (drawing cleaned for reproduction).

Occasionally, if rarely, construction drawings, lumber lists or contracts exist for a destroyed structure. You can look for these in church records, local historical societies or manuscript collections at universities. St. Paul’s Episcopal Church, Windsor, Vermont (1822), still possesses the original elevations of the church façade and tower, drawn by its architect Alexander Parris (Fig. 14).

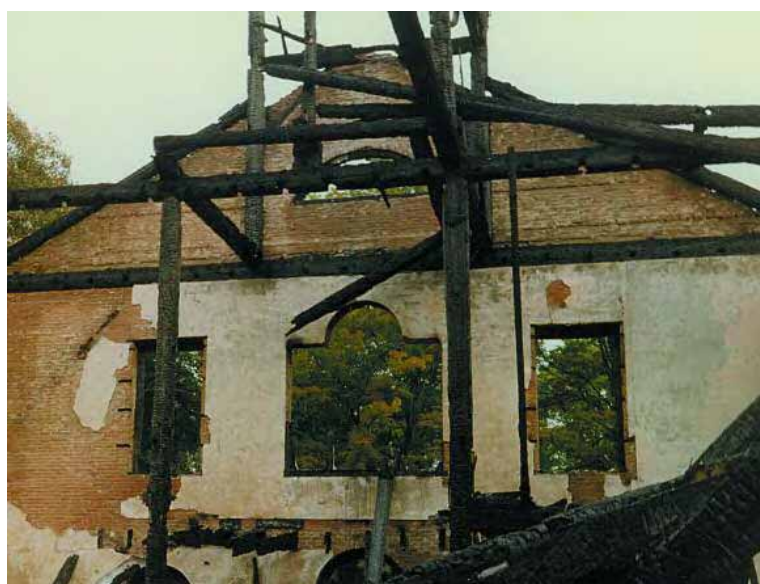
**T**HE WEATHERSFIELD MEETINGHOUSE. In 1985 a fire destroyed all the timber portions of the 1826 Weathersfield, Vermont, Meetinghouse, leaving the brick walls standing (Fig. 16). The church's insurance company was quick to offer a check for the insured value, but the policy also promised to replace the building in kind. A determined church committee waved away the first offer and decided to discover what "in kind"

Fig. 16. Weathersfield standing timber remains included three tower posts, inset front plate, sleepers, first truss tie beam and vestibule posts.

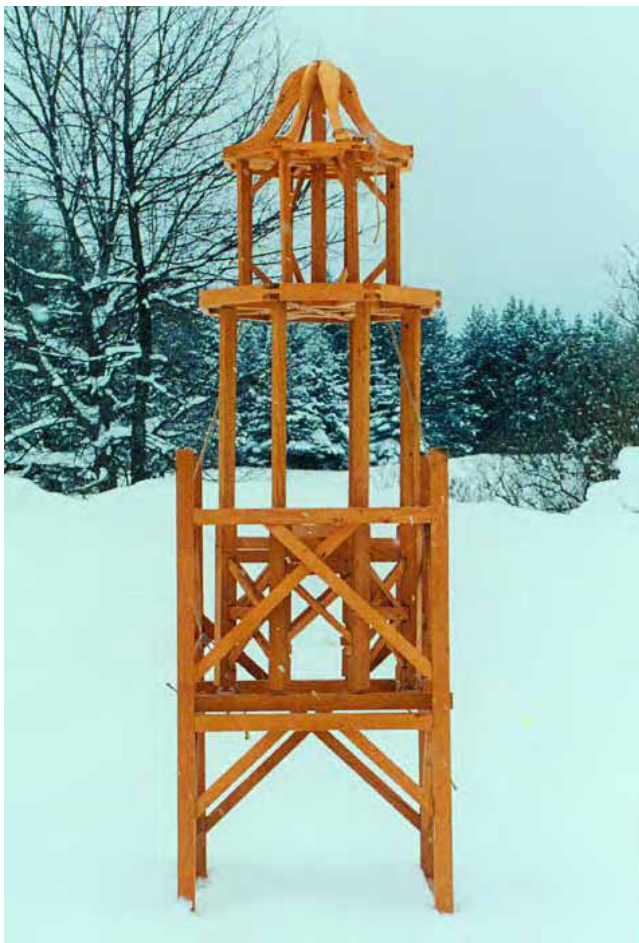
*Fig. 17. One-inch-scale Weathersfield steeple model in spruce and with correct joinery, built by Ted Ingraham. Model stands 70 in. high.*

The next step was to build 1:12 scale models of truss and steeple as aids to framing and, more important, guides to order of assembly and erection. The models, built with correct joinery, would help me explain to the architects, owners and other interested parties how the

steeple was designed to be erected in discrete, lodged, telescoping stages, and how we would accomplish this task (Fig. 17).

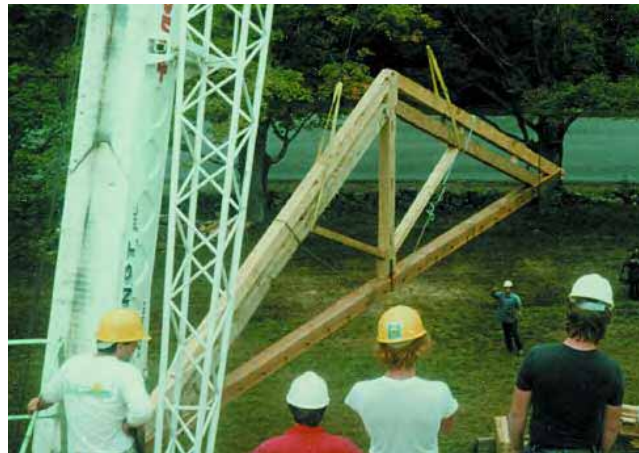
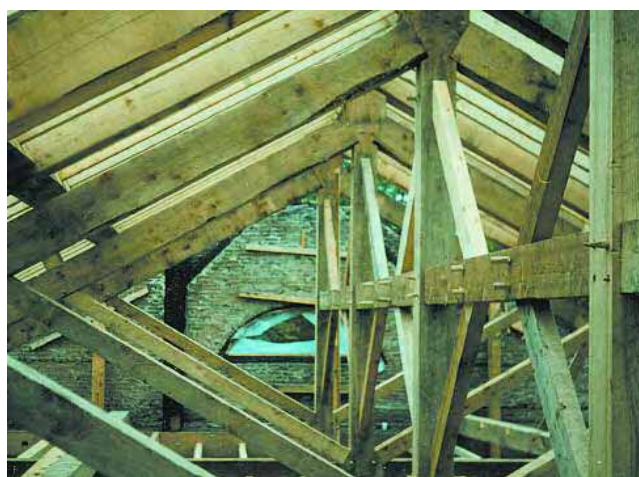
*Figs. 18–19. Weathersfield truss fly-in was complicated by making up the closed mortise and tenon joinery of many connecting members.*

The trusses were fully framed on the ground and cambered according to directions found in Peter Nicholson's *The Carpenter's New Guide* (1837). To produce camber, Nicholson advocates that principal rafters be lengthened and "forced in framing," rather than shortening the kingpost. Lengthening the rafters forces the kingpost upward, dragging the middle of the bottom chord with it. The longer rafters also compensate for shrinkage and compression that normally occur across the flared kingpost head, allowing the truss to sag. Despite Nicholson's advice, builders often added camber to trusses by shortening kingposts or using tie beams naturally curved or hewn to a camber.

The assembled trusses were then flown into position atop the plates and their closed mortises engaged, laboriously, with the 32 tenons awaiting each side of each truss. These tenons belonged to longitudinal girts and bracing entering the kingposts, purlins entering the upper rafters and many ceiling joists entering the tie beams (Figs. 18–19). At this point in my heavy-timber-framing career, I had not discovered that practical framers of the past had invented at least four methods of insertion (TF 76:23) to avoid having to engage all the ceiling joists simultaneously.

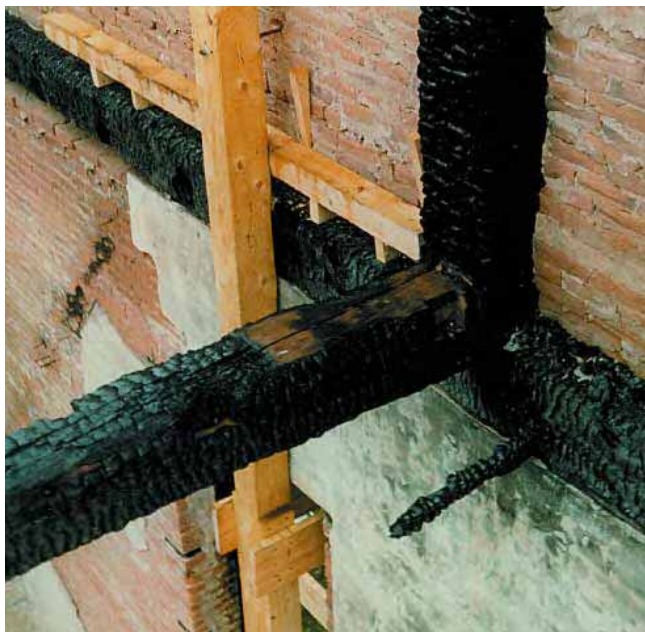
Fig. 20. Charred remains of inset plate, front tower post and long sleeper to carry steeple. New material is part of front-wall shoring.

inset plate on the interior of the front brick wall and ran back to span two kingpost roof trusses (Fig. 20). Two 10x10 vestibule posts rose from the ground to the underside of the first interior truss to help carry the rear steeple load. The plate, sleepers and vestibule posts were all replaced in dimension, species and joinery.

*Framing the steeple.* The original Weathersfield steeple was lodged at the bottom upon two 12x12x28-ft. spruce sleepers, one fortunately still in position after the fire. The sleepers began at the

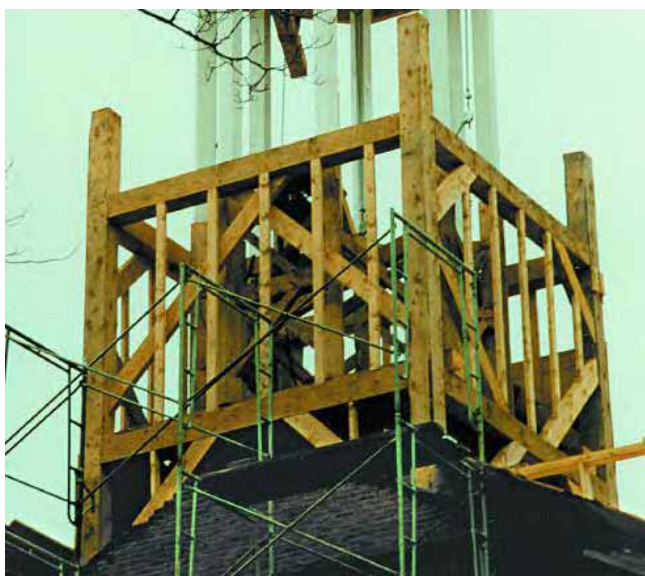
Fig. 21. Weathersfield tower frame in place, well braced and studded for exterior finish. Posts descend to long sleepers in attic and carry short sleepers halfway up to foot belfry posts. See also Fig. 17.

The first stage, the square tower, 14 ft. on a side and 25 ft. tall, had abundant crossing bracing and a square of short sleepers lodged halfway up to accept the bottoms of the eight telescoping belfry posts. The sleepers lodged on girts tenoned into the 10x10 tower posts, and the two girts that carried the four extended ends of the 12-ft. belfry crib were reinforced by mortised 4x6 studs that dropped to the long sleepers below. The tower frame made itself

further useful and expressive by providing rigid centers for the cased newel posts in the bell deck balustrade (Fig. 21).

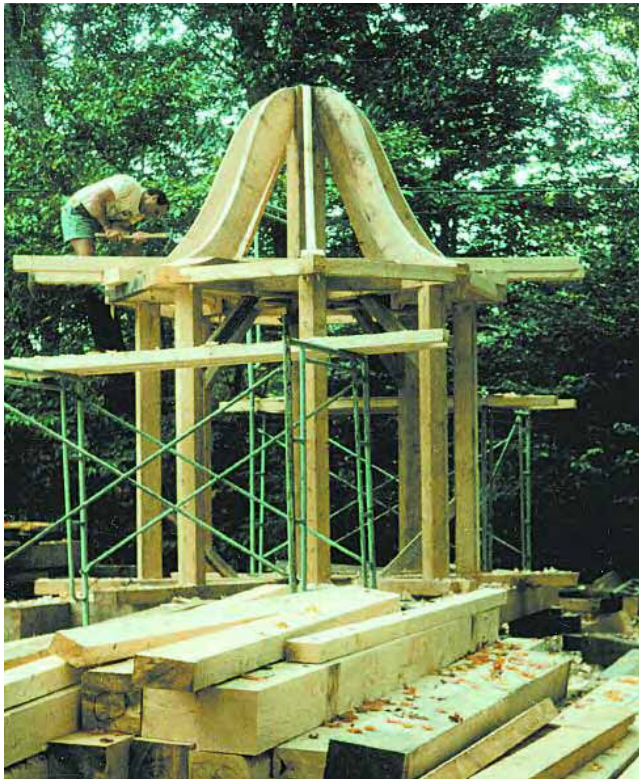
*Fig. 23. Mike Cotroneo fairing legs of lantern crab to cupola roof's ogee rafters. An adze in good hands remains unsurpassed for such work. Lantern posts will tenon to major crab atop belfry in Fig. 24.*

The desired framing of the lantern, the top stage, was less obvious. We had the remains of a mast that anchored the weather-vane and rose the full height of the lantern and its cupola roof. How it could pass through a crab was unclear, so for the lantern crab that would carry its cupola roof we altered the typical design of the period by turning its main axis into partners, parallel timbers spaced apart, to accommodate the mast we knew to be original. The ogee rafters of the lantern's cupola roof were cut from solid 2½x18 white pine plank, and careful adzing continued their curve onto the supporting crab legs (Fig. 23 overleaf).

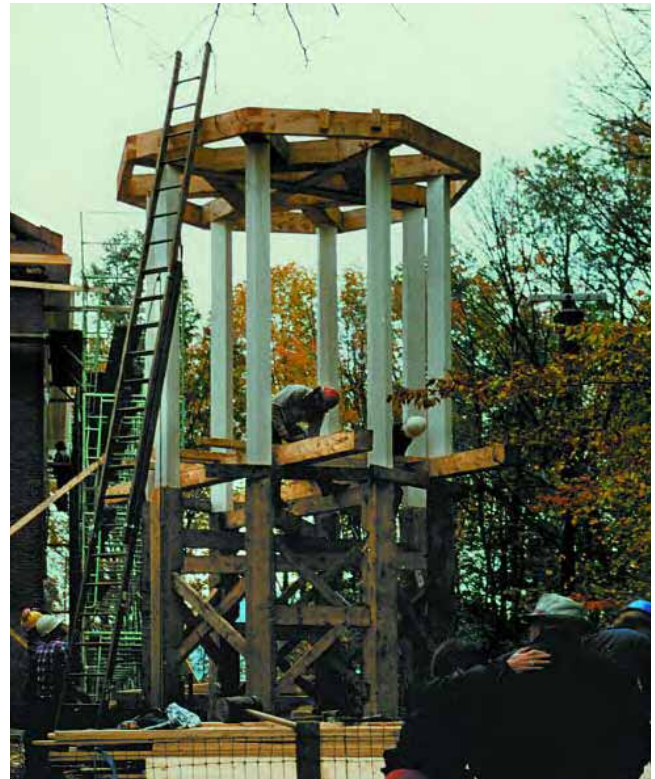
*Fig. 24. Belfry frame with major crab installed on top to carry lantern. Workers rig heavy lifting timbers that will bear under the crab to transport the assembly to the meetinghouse.*

The design for the major crab, the eight-legged horizontal frame that supports the lantern, was suggested by some burned remains and a complete period design provided by examples from the John Johnson papers at the University of Vermont (Figs. 22 and 24).

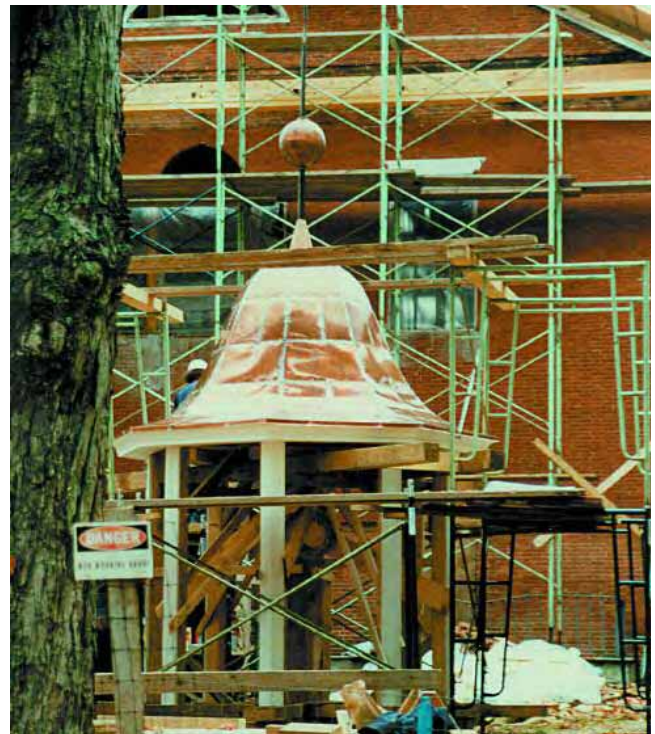
*Fig. 25. Lantern covered by soldered copper cupola roof, topped by mast with orb (weathervane unseen above), awaits lift to top of belfry. Timbers just under cornice will be strapped to lift the stage.*

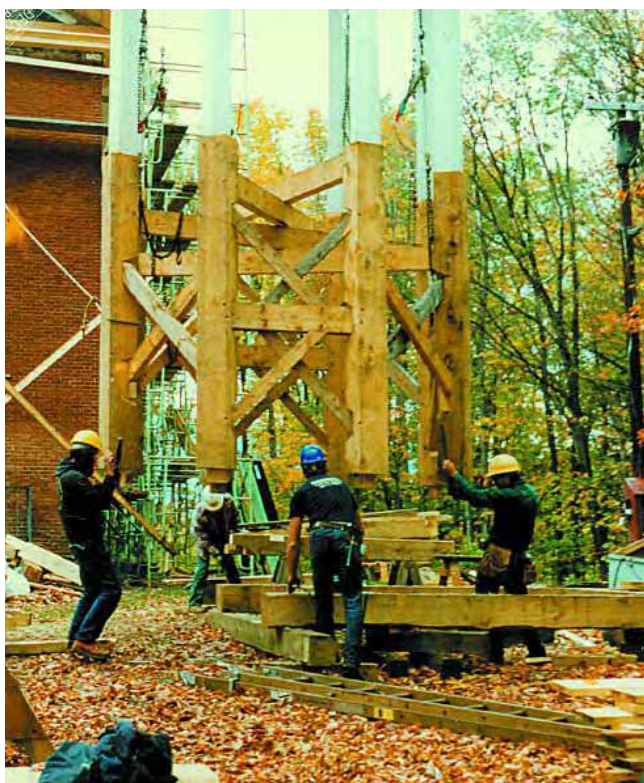
Fig. 26. Belfry frame with lantern (unseen) lifts off. Scale of work, hardly apparent once steeple is in place, is plain enough near the ground. Braces and girts were added to frame design to counter vibration.

A 75-ton hydraulic crane, our modern powered version of an external gin pole, first placed the framed tower onto the sleepers crossing the truss chords. Next the crane placed the cupola with its eight post-bottom tenons, eight descending brace tenons and the mast tenon, onto the crab atop the belfry, still on the ground. The belfry sleepers were then flown into place on the steeple tower at the mid-tower girts. The crane lifted the belfry-cupola combination above the tower plate level and then lowered it to the waiting sleeper mortises inside. The cambered bell girts were next; they would have run afoul the belfry octagon bracing had they been in place already. The bell itself was then flown in alongside the belfry, transferred to comealongs within the belfry and hung from the crab, allowing carpenters and roofers to complete the bell deck below them. The steeple assembly took two days. On one day the tower was inserted. On the next all the other stages and heavy girts and the bell were put in place. Flashing, skirting roofs and the remaining exterior woodwork then followed.

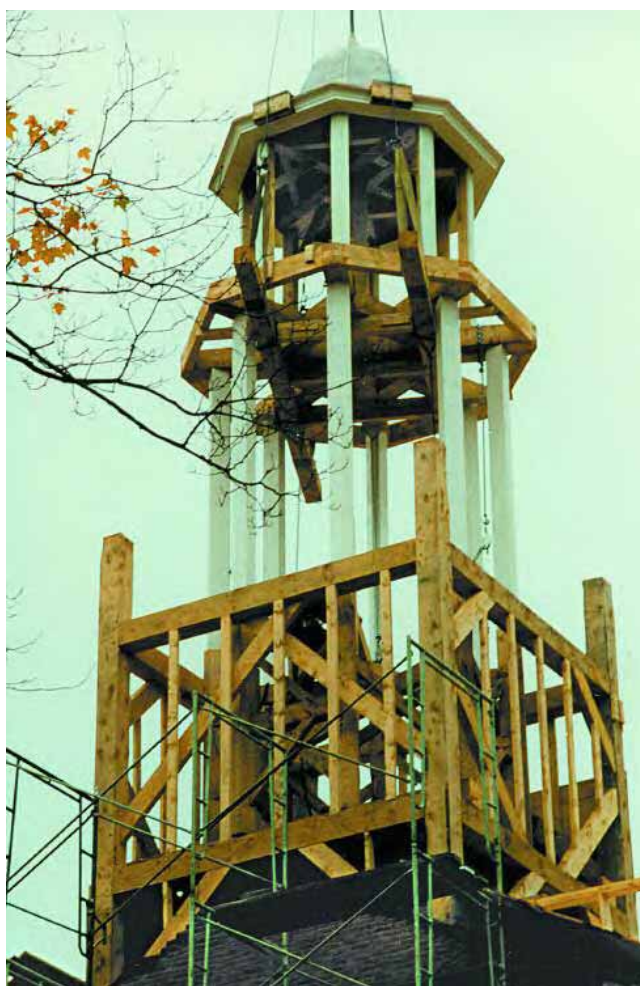
Fig. 27. Completed steeple frame installed on meetinghouse, awaiting bell girts and bell and considerable finish work. Crab with partners to allow passage of central mast visible in ceiling of lantern.
